## **INSTALLATION INSTRUCTIONS**

### **BULL BAR**

### **01-07 TOYOTA HIGHLANDER**

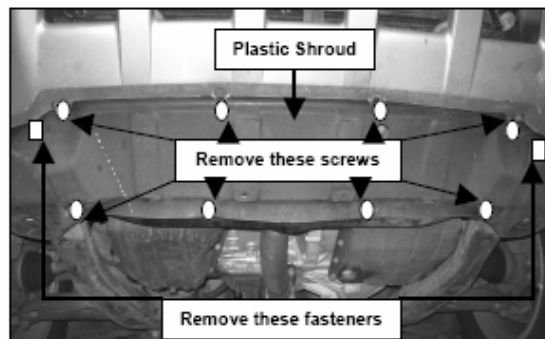
Figure 2

**2.** Carefully remove the plastic shroud underneath the vehicle by removing the (4) screws on top, (4) screws on bottom, and (1) fastener on each side (Figure 2).

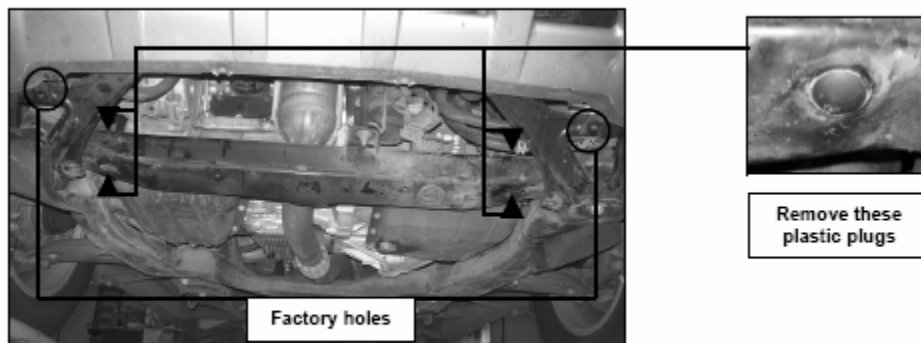
Figure 3

**3.** Remove the plastic plugs on the cross bar member. There is one on the passenger side and one on the driver side, top and bottom of cross member bar (Figure 3).

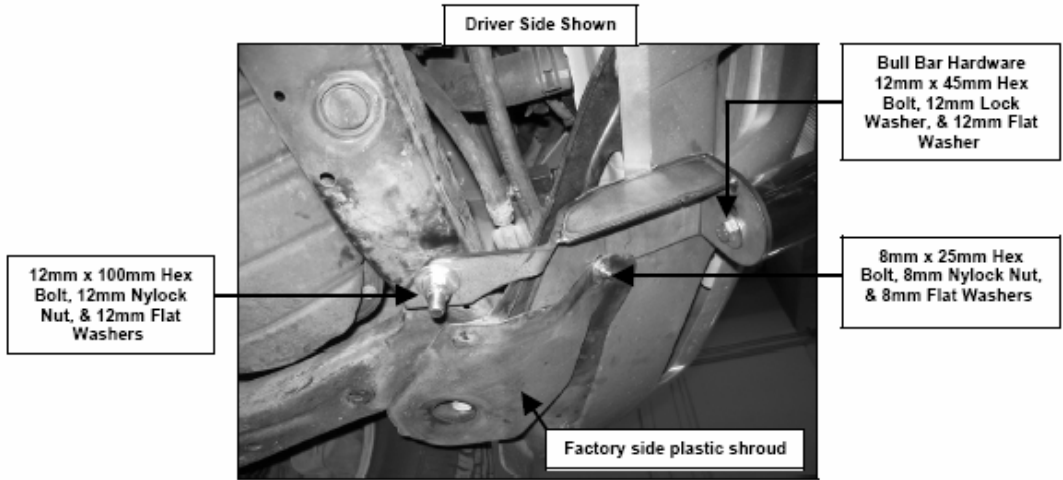
Figure 4

**4.** Position Driver Side Mounting Bracket to vehicle and align holes on the bracket to factory holes. The rear most hole to the Mounting Bracket mounts to the cross bar member using (1) 12-1.75mm x 100mm Hex Head Bolt, (1) 12mm Nylock Nut, and (2) 12mm Flat Washers. The front hole on the Mounting Bracket mounts to the factory bumper support by using (1) 8-1.25mm x 25mm Hex Head Bolt, (1) 8mm Nylock Nut, and (2) 8mm Flat Washers, use this hardware to re-attach the side factory plastic shroud (Figure 4). **NOTE:** To ease the

installation insert bolts with flat washer listed in this step through the top of the cross bar member and bumper support. Do not tighten at this time. Repeat this step for passenger side.

**5.** Position Bull Bar onto Mounting Brackets and loosely attach it with the included (2) 12-1.75 x 45mm Hex Head Bolts, (2) 12mm Flat Washers, and (2) 12mm Lock Washers (Figure 4).

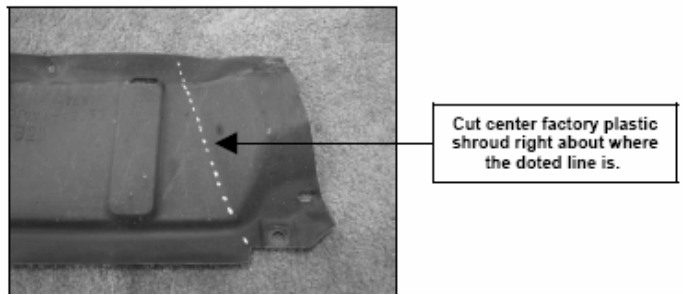
**7.** In order to re-install the plastic shroud, some cutting is necessary. Once the Bull Bar is fully mounted, place the center plastic shroud to its original position and mark where it needs to be cut (Figure 5). Re-install plastic shroud with factory hardware removed in step 1.
